WLCC Report on Water Flow in the Williams Lake Watershed - November 25, 2020

Prepared for the WLCC by Melanie Dobson and members of the WLCC Executive Committee

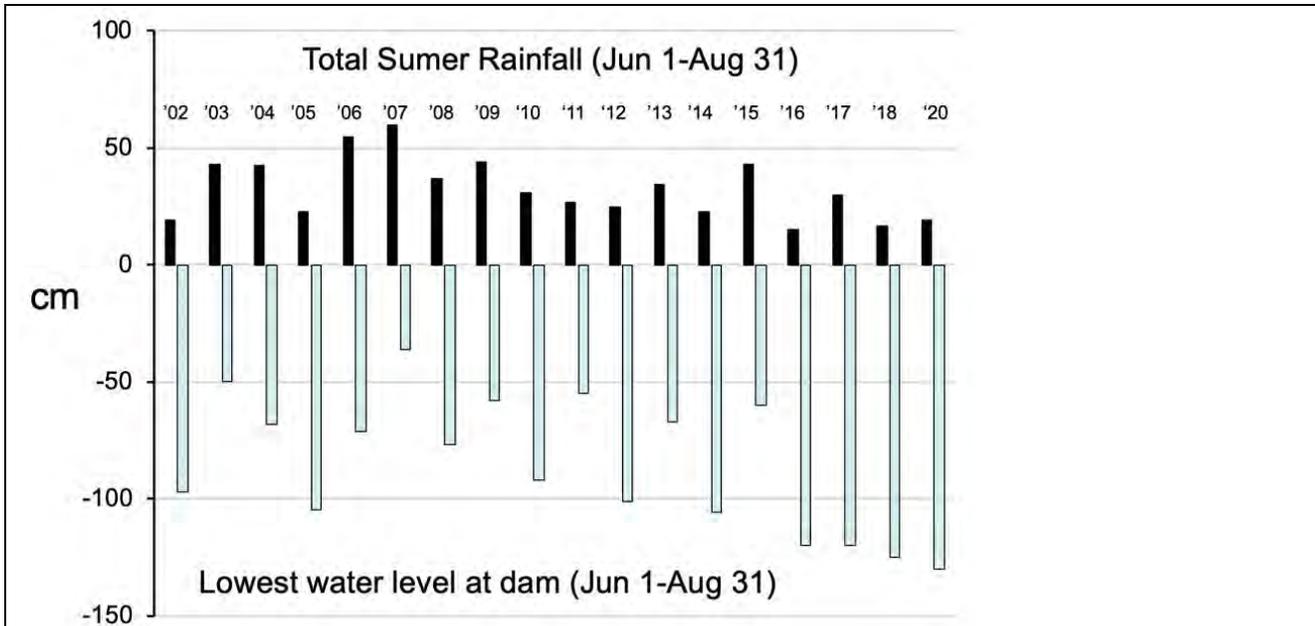
Figure 1. Measurements by the WLCC taken during the summer from 2002-2020 show that Williams Lake levels are lower in summers with less rain but also that levels have been falling significantly lower than in past (~1 inch lower /year).

Williams Lake is an urban lake that gives more than it gets. Water levels in the lake have been getting lower over the past 20 years. The Williams Lake Conservation Company (WLCC), a non-profit volunteer community-based organization, has had a stewardship role with the lake for the past 50+ years, which includes monitoring lake levels and water quality. Recent summers have seen Williams Lake water levels fall lower than ever before (See Figure 1).

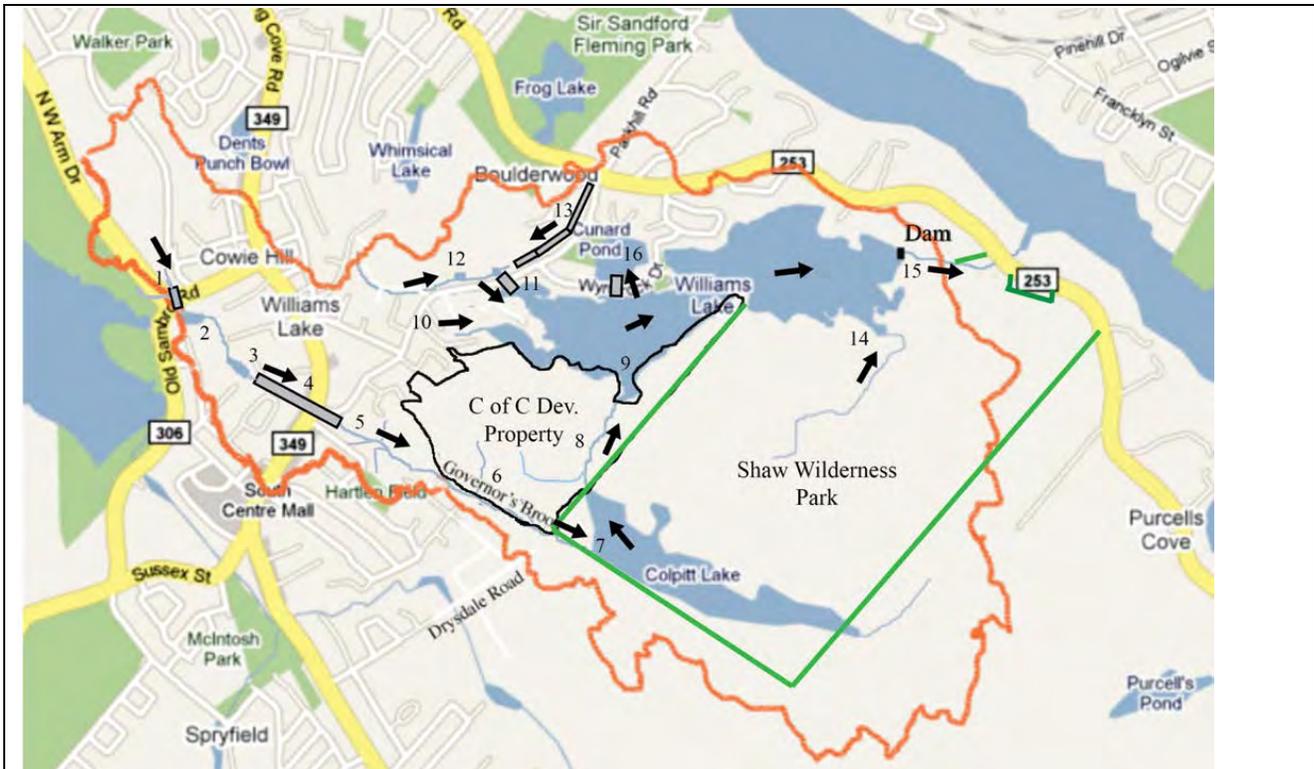
Figure 2. Water flow in the Williams Lake Watershed. Key sources of water supply to Williams Lake with the direction of water flow indicated with arrows. Water courses directed through culverts/underground pipes are indicated with grey rectangles. The boundary of the Williams Lake watershed is shown in red (mapping data courtesy of Dr. Patricia Manuel) and indicates the land where precipitation would normally be fed towards Williams Lake through streams and other water bodies and by percolating through the ground. The lands owned by the Church of Christ Development Corporation (C of C Dev. Property) and the Shaw Wilderness Park are outlined (black and green lines, respectively). Sites referred to in the text of the report are numbered on the map.

The Williams Lake Watershed is surprisingly extensive, reaching from far north along Dunbrack Drive, west and south into Spryfield and beyond the Shaw Wilderness Park on the south and east (See Figure 2 for overview of water flow and Figure 3 for more detail on the water courses and the location of recent developments in the watershed). See the Appendix for photographs of sites within the watershed.

Water originating on the hillside east of Dunbrack and from ditches along the road is piped under the junction with the Old Sambro Road (1) and feeds into Catamaran Pond (2). Water then flows through a wetland to a second pond at the end of Lewis Street (3). Water from this pond flows into a culvert in the Feruz Crescent Development behind the Sobeys store on Herring Cove Road. From there, the water is piped underground and eventually discharges (with other storm drain run-off from Herring Cove Road and the top part of Williams Lake Road) from a large diameter pipe outlet in the woods (5) below the parking lot of the church on the corner of Williams Lake and Herring Cove Roads. This is now

considered the beginning of Governor's Brook (presumably in past before development in the area, it would have flowed overland from the Lewis Street pond).

Governor's Brook is fed by other streams and water originating in the C of C Lands (6) and discharges into Colpitt Lake (7). Colpitt Lake is a major water supply for Williams Lake (9). The stream connecting the two (8) lies in the C of C Lands and flows year-round, even in hot dry summers when lake levels have been low, supplemented by water coming from other parts of the C of C land.

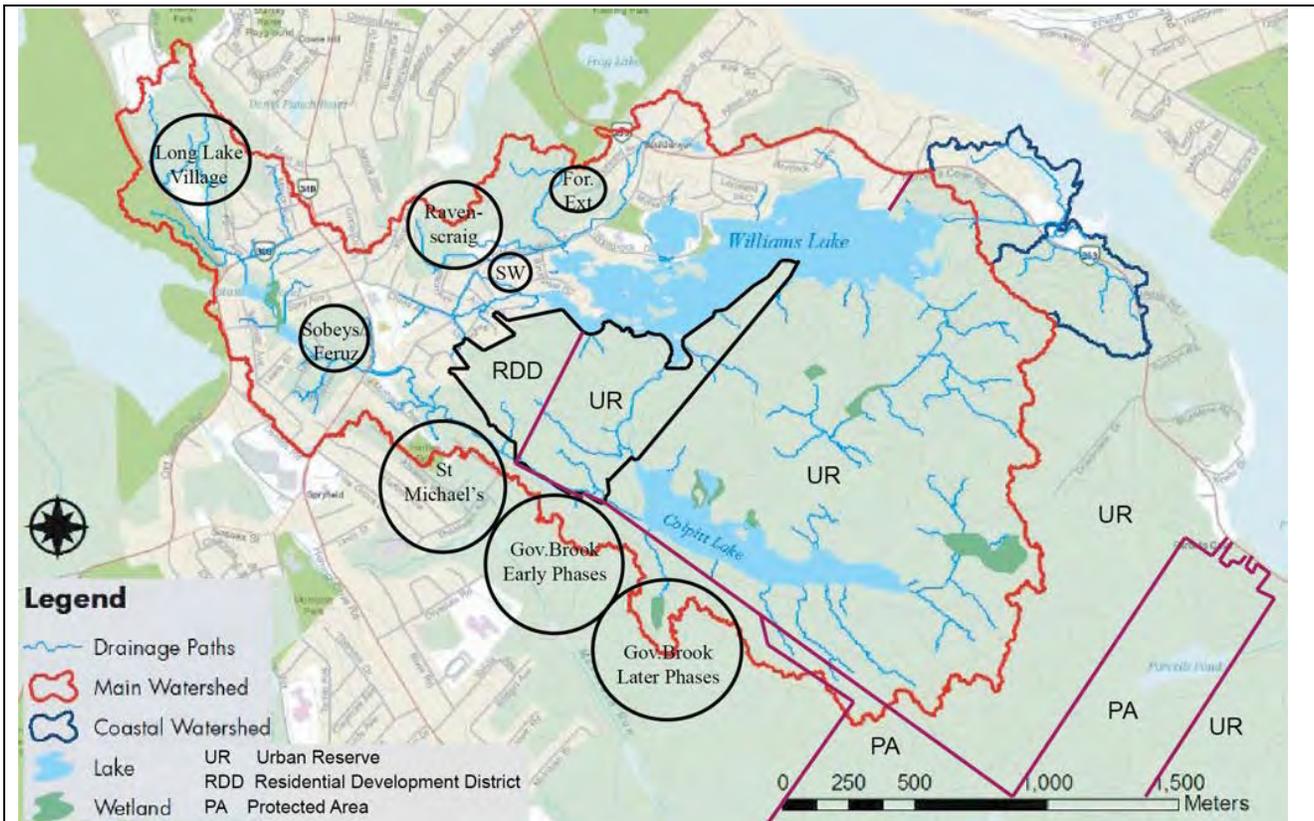
Figure 3. Positions of Recent Developments in the Williams Lake Watershed (2000-current) and Current Zoning of Undeveloped Land. Watershed Map is courtesy of Dr. Patricia Manuel. Developments indicated are Governor's Brook Early Phases (2010) and Later Phases (2012-), Feruz Crescent/Lovell Lane) (2003-2007), Sobey's (2000-2003), Ravenscraig (2006-2012), Forward Avenue Extension (For. Ext)(2002-2009), Sagewood Avenue (SW)(2008-2009), St. Michaels Early Phase (1997) and Later Phase (2004-2009), Long Lake Village (2016-current).

Multiple significant housing developments have been built in the Williams Lake Watershed in the past 20 years, many of which have altered natural water courses (See Figure 3). Developments have included: St. Michael's (1997-2009), Governor's Brook (early phases 2010-2012 and later phases 2012-ongoing) (Sobey's and the Feruz Crescent neighbourhood 2000-2007), (Ravenscraig 2006-2012), Sagewood 2008-2009), Forward Avenue Extension (2002-2009), and Long Lake Village (2016-current). These developments represent a significant loss of permeable surface in the watershed due to the addition of driveways, roads and parking lots. Rather than be retained and percolating slowly through the ground, rainwater captured by storm drains moves rapidly through the watershed. Sediments do not have time to settle and hydrocarbons do not readily evaporate in closed systems, making the water that is delivered into streams and lakes more highly contaminated. Blasting to level building sites changes elevations and disrupts normal water flow and in some cases, water has been diverted away from the watershed (for example, early phases of the Governor's Brook Development directly impacted water supply to the Williams Lake Watershed, by having storm drains designed to divert run-off away from Colpitt Lake and towards the MacIntosh Run, a different watershed).

The western end of Williams Lake has already been severely compromised by several Developments that have directly impacted the water flow into that end of the Lake both in terms of quality and quantity (See Figure 3). Reconfiguration of the junction of Dunbrack with the Old Sambro Road when the Northwest Arm Drive was upgraded, and the housing development of Feruz Crescent/Lovell Lane immediately adjacent to the ponds behind the Sobeys store, and the large car parks at Sobeys and the adjacent Shoppers Drugmart, have increased water capture to storm drains and decreased water quality reaching Governor's Brook. The WLCC water quality monitoring program has noted changes in some chemical parameters for Governor's Brook outflow samples that may reflect these impacts.

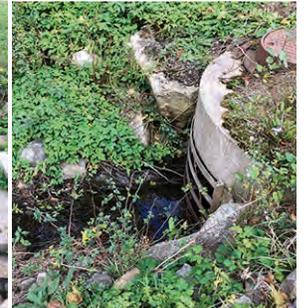
c. Lewis St. Pond outflow culvert, left, dry on Oct 12, right, some flow, Oct 25, 2020

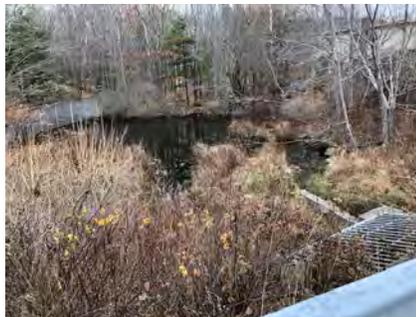
m. Detention pond on Williams Lake Road, Nov 25

A major source of water at the western end of Williams Lake is delivered through a culvert under the Williams Lake Road from a duck pond on the north side of the road (11). The pond was originally designed to prevent storm drain run-off from the Purcell's Cove Road end of the Williams Lake Road from entering the lake too quickly. The pond was enlarged as part of the work done when the open ditches along the eastern end of Williams Lake Road were converted to a piped collection system in ~1999 (13). The pond also receives the water that now runs westward from the extended Forward Avenue Development, and eastward off the Ravenscraig Development (12). Prior to the development of Ravenscraig, there was a year-round stream flowing at the western side of the site that delivered water to Williams Lake and to a wetland higher up on Williams Lake Road. That water is now channeled through a series of engineered open swales behind the houses on the lower part of the Development and along the playing fields. The engineered swales and another wetland (beyond the playing field above the detention pond (12), and the detention pond itself, have become overgrown and it is not clear they are filtering and clearing the water as well as originally intended. WLCC monitoring of water quality at the west end of Williams Lake has shown a significant deterioration in quality relative to water sampled at the eastern end of the lake.

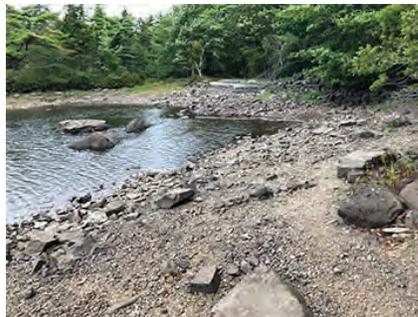
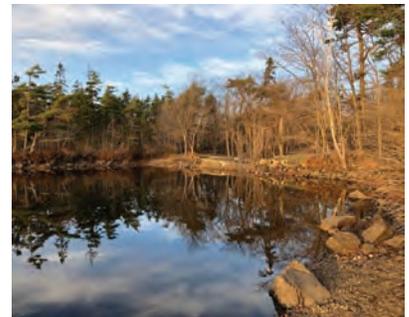
n. Williams Lake dam, (left) on Sept 10, and (right) on Nov 15

Water leaves Williams Lake through Lawson's Creek at the far eastern end (15) and flows under the Purcells Cove Road and through a grated culvert under a bridge at the Royal Nova Scotia Yacht Squadron and into the Northwest Arm. A dam has existed at the outflow into Lawson's Creek since the 1700's, allowing the lake to be maintained at a level that could provide water power, later, a supply of ice for the city, and more recently as a recreational resource for HRM residents, while still ensuring enough outflow to keep Lawson's Creek running. The dam has been repaired many times over the years and is now again in need of remediation.

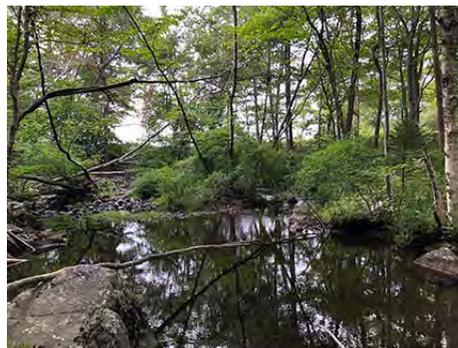
o. Lawson Creek below dam, Sept. 10,
